## Replacement of Upholstered Top:

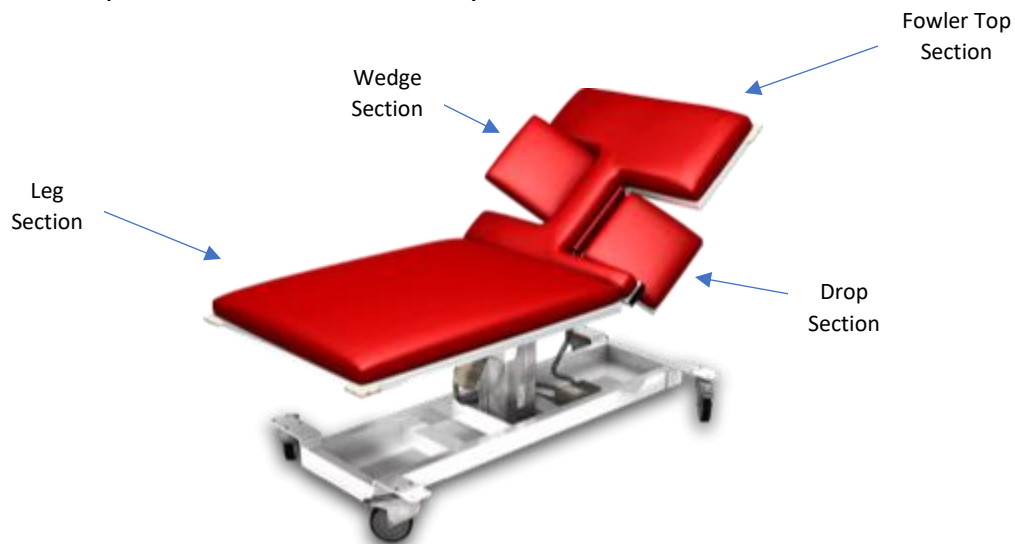
- Line the new top up with the frame and using a 1/8" bit, pre-drill holes for the screws that hold the top to the frame.
- Attach the top to the frame with the screws removed earlier. Do not over tighten the screws –they can strip easily. The flap is the portion of vinyl upholstery in between the Imaging Drop Section and the bed.

- To remove an upholstery section top from the frame it is necessary to remove the screws from the bottom side of the frame that hold the upholstered top to the frame.

- Put the bed in a flat position, pull the upholstered section top from the frame and lay it over onto the bed. This will expose the bottom side of the upholstered top.

- Remove the staples holding the flap to the upholstered top and place the top aside.
- Put the new upholstered top in the same position as the previous one was on the bed and reattach the flap to the new top in approximately the same location as it was on the previous top.

- Repeat the process for each section on your exam bed.
